ADDENDUM NO. 1 TO ALL BIDDERS/OFFERRORS:

Reference – RFP 2023-005

Description: Assessment of Facilities, Personnel, and Apparatus for Roanoke County Fire & Rescue Department.

**APPENDIX C: ASSET SUMMARY REPORTS**

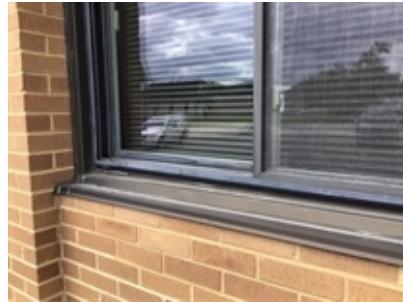
Work Item Number <b>B202001003-102772</b>	Work Item Name <b>Replace Windows</b>	Year Observed <b>2019</b>
--	--	------------------------------

**Inventory Classification** B202001003 - Steel Operable Window (3' X 5') Dbl Pane (1/4")

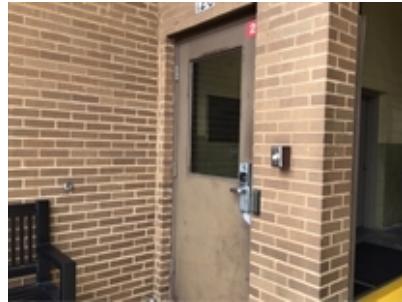
Work Item Number <b>B203001001-102773</b>	Work Item Name <b>Paint Exterior Doors</b>	Year Observed <b>2019</b>
--	---	------------------------------

**Inventory Classification** B203001001 - Hollow Metal Door w/Frame (3'0" X 7'0")

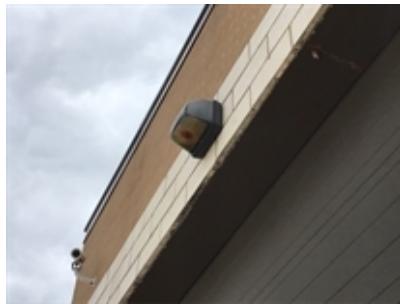
Work Item Number	Work Item Name	Year Observed
D502002005-102771	Replace Exterior Lighting	2019

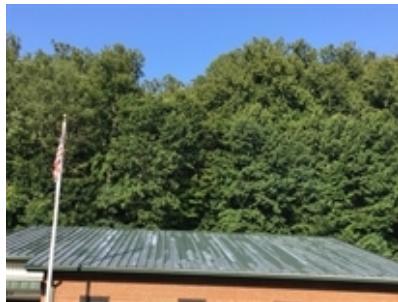
Work Item Number <b>B301001002-102731</b>	Work Item Name <b>Replace Standing Seam Metal Roof</b>	Year Observed <b>2019</b>
--	---	------------------------------

**Inventory Classification** B301001002 - Standing Seam Metal Roof

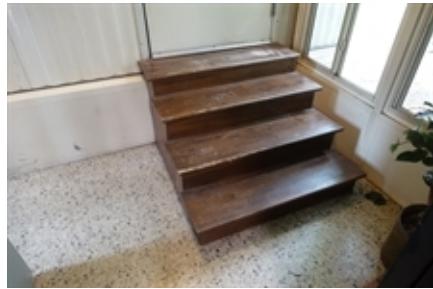
Work Item Number <b>C201001009-101991</b>	Work Item Name <b>Non-compliant Steps</b>	Year Observed <b>2019</b>
--	--	------------------------------

**Inventory Classification** C201001009 - Interior Stairs, Wood, Steps

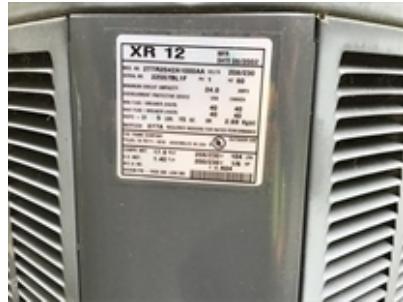
Work Item Number	Work Item Name	Year Observed
D305006019-102053	Replace Bunkroom AC System	2019

<b>Inventory Classification</b>	D305006019 - A/C Unit, Split Systems w/ Air Cooled Condenser - 3.5 TN	
<b>Description</b>	3.5 ton Condensing Unit with Split Dx Coil at Furnace	
<b>Section</b>	Bunkroom AC	
<b>Distress Type</b>	Deteriorated	
<b>Work Category</b>	Repairs and Replacements	
<b>Green Opportunity</b>	Energy Efficiency	
<b>Green Evaluation</b>	Energy Performance	
<b>Status</b> Active	<b>Assigned to Work Package?</b>	Yes
<b>Current DCR</b> R	<b>Work Package ID</b>	D30-95890
<b>Estimated Improved DCR</b> G+	<b>Budget Category/Account</b>	Sustainment-Deficiency Repairs/Replacements

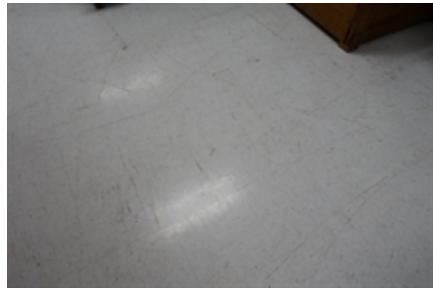
Work Item Number <b>C302004001-102679</b>	Work Item Name <b>Replace Vinyl Flooring</b>	Year Observed <b>2019</b>
--	---	------------------------------

**Inventory Classification** C302004001 - Vinyl Tile 1/8" X 12" X 12"

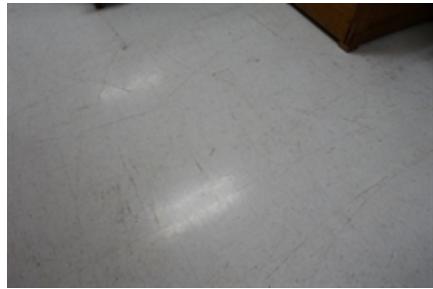
Work Item Number <b>C302004001-102680</b>	Work Item Name <b>Replace Vinyl Flooring</b>	Year Observed <b>2019</b>
--	---	------------------------------

**Inventory Classification** C302004001 - Vinyl Tile 1/8" X 12" X 12"

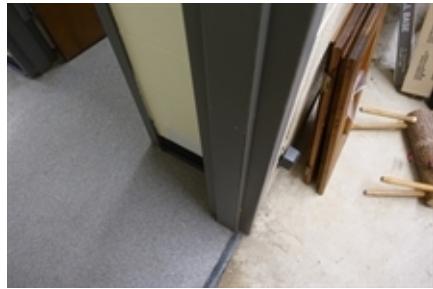
Work Item Number	Work Item Name	Year Observed
C302005001-102681	Replace Carpeting	2019

<b>Inventory Classification</b>	C302005001 - Commercial Grade Carpeting, 35oz Nylon	
<b>Description</b>	Carpet	
<b>Section</b>	2FL	
<b>Distress Type</b>	Deteriorated	
<b>Work Category</b>	Repairs and Replacements	
<b>Green Opportunity</b>		
<b>Green Evaluation</b>		
<b>Status</b> Active	<b>Assigned to Work Package?</b>	Yes
<b>Current DCR</b> R	<b>Work Package ID</b>	C30-96013
<b>Estimated Improved DCR</b> G	<b>Budget Category/Account</b>	Sustainment-Deficiency Repairs/Replacements

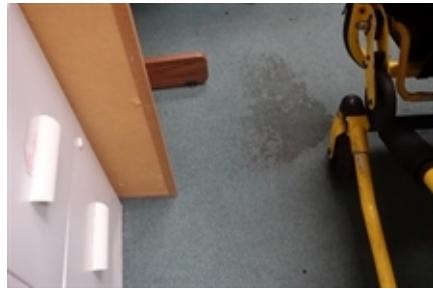
Work Item Number	Work Item Name	Year Observed
C302005001-102682	Replace Carpeting	2019

<b>Inventory Classification</b>	C302005001 - Commercial Grade Carpeting, 35oz Nylon	
<b>Description</b>	Carpet	
<b>Section</b>	1FL	
<b>Distress Type</b>	Deteriorated	
<b>Work Category</b>	Repairs and Replacements	
<b>Green Opportunity</b>		
<b>Green Evaluation</b>		
<b>Status</b> Active	<b>Assigned to Work Package?</b>	Yes
<b>Current DCR</b> R+	<b>Work Package ID</b>	C30-96013
<b>Estimated Improved DCR</b> G	<b>Budget Category/Account</b>	Sustainment-Deficiency Repairs/Replacements

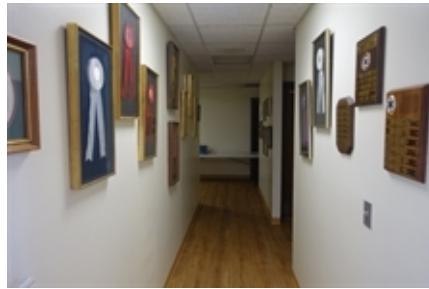
Work Item Number <b>C303004001-102685</b>	Work Item Name <b>Replace Ceiling tile</b>	Year Observed <b>2019</b>
--	---	------------------------------

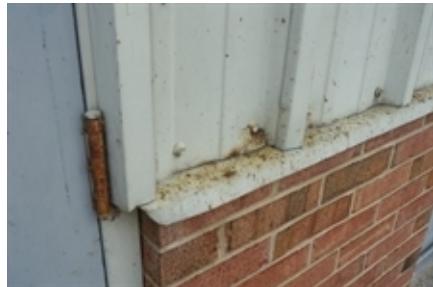
Work Item Number <b>B201001005-102346</b>	Work Item Name Deteriorated metal siding and associated metal door trim	Year Observed <b>2019</b>
--	--	------------------------------

<b>Inventory Classification</b>	B201001005 - Metal Siding, w/Vinyl Backed Insulation	
<b>Description</b>		
<b>Section</b>	-	
<b>Distress Type</b>	Deteriorated	
<b>Work Category</b>	Repairs and Replacements	
<b>Green Opportunity</b>		
<b>Green Evaluation</b>		
<b>Status</b> Active	<b>Assigned to Work Package?</b>	Yes
<b>Current DCR</b> R+	<b>Work Package ID</b>	B20-96019
<b>Estimated Improved DCR</b> G	<b>Budget Category/Account</b>	Sustainment-Deficiency Repairs/Replacements

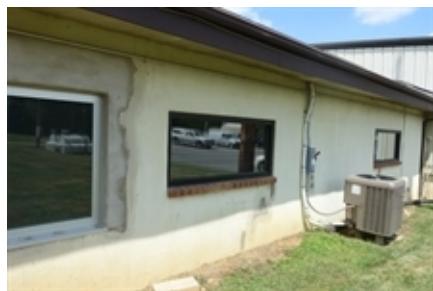
Work Item Number	Work Item Name	Year Observed
B201001006-102345	Failing stucco and associated wood trim	2019

**Inventory Classification** B201001006 - Stucco, Lath, 3 Coats, 1" Thick, No Backup

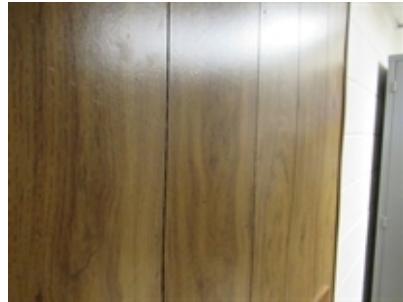
Work Item Number <b>C301006003-102686</b>	Work Item Name <b>Replace Wood Paneling</b>	Year Observed <b>2019</b>
--	--	------------------------------

<b>Inventory Classification</b>	C301006003 - Wood Paneling Sheet Wall Covering	
<b>Description</b>	-	
<b>Section</b>	Civic Club	
<b>Distress Type</b>	Deteriorated	
<b>Work Category</b>	Repairs and Replacements	
<b>Green Opportunity</b>		
<b>Green Evaluation</b>		
<b>Status</b> Active	<b>Assigned to Work Package?</b>	Yes
<b>Current DCR</b> R	<b>Work Package ID</b>	C30-96020
<b>Estimated Improved DCR</b> G	<b>Budget Category/Account</b>	Sustainment-Deficiency Repairs/Replacements

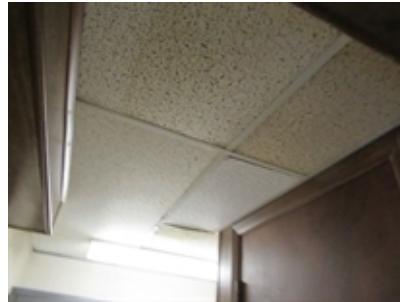
Work Item Number <b>C303004001-102687</b>	Work Item Name <b>Replace Ceiling Tile</b>	Year Observed <b>2019</b>
--	---	------------------------------

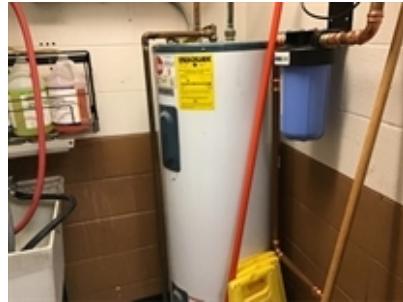
Work Item Number	Work Item Name	Year Observed
D202003017-102353	Replace Water Heater on First Floor	2019

<b>Inventory Classification</b>	D202003017 - Residential Water Heater - Electric or Gas, 50 gal		
<b>Description</b>	Electric Water Heater		
<b>Section</b>	WH 1		
<b>Distress Type</b>	Deteriorated		
<b>Work Category</b>	Repairs and Replacements		
<b>Green Opportunity</b>	Energy Efficiency		
<b>Green Evaluation</b>	Energy Performance		
<b>Status</b>	Active		
<b>Assigned to Work Package?</b>	Yes		
<b>Current DCR</b>	R+		
<b>Work Package ID</b>	D20-96021		
<b>Estimated Improved DCR</b>	G+	<b>Budget Category/Account</b>	Sustainment-Component Renewal at ESL

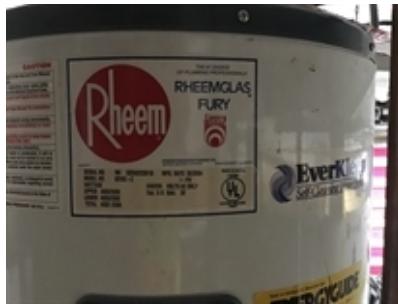
Work Item Number	Work Item Name	Year Observed
D202003017-102354	Replace water heater on Mezzanine	2019

<b>Inventory Classification</b>	D202003017 - Residential Water Heater - Electric or Gas, 50 gal	
<b>Description</b>	Electric Water Heater	
<b>Section</b>	WH 2	
<b>Distress Type</b>	Deteriorated	
<b>Work Category</b>	Repairs and Replacements	
<b>Green Opportunity</b>	Energy Efficiency	
<b>Green Evaluation</b>	Energy Performance	
<b>Status</b> Active	<b>Assigned to Work Package?</b>	Yes
<b>Current DCR</b> R+	<b>Work Package ID</b>	D20-96021
<b>Estimated Improved DCR</b> G+	<b>Budget Category/Account</b>	Sustainment-Component Renewal at ESL

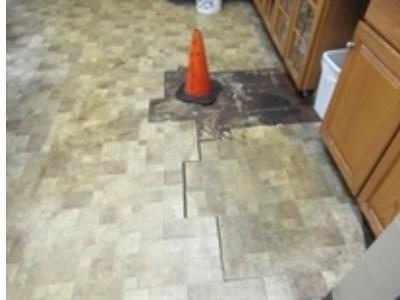
Work Item Number <b>C302004002-102688</b>	Work Item Name <b>Replace Sheet Vinyl Flooring</b>	Year Observed <b>2019</b>
--	---	------------------------------

**Inventory Classification** C302004002 - Sheet Vinyl Flooring

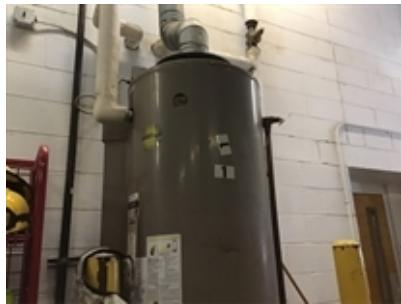
Work Item Number	Work Item Name	Year Observed
D202003019-102358	Replace Water Heater	2019

<b>Inventory Classification</b>	D202003019 - Commercial Water Heater - Elec, Gas or Oil Fired - 200 MBH
<b>Description</b>	Gas Fired Water Heater
<b>Section</b>	WH
<b>Distress Type</b>	Deteriorated
<b>Work Category</b>	Repairs and Replacements
<b>Green Opportunity</b>	Energy Efficiency
<b>Green Evaluation</b>	Energy Performance
<b>Status</b> Active	<b>Assigned to Work Package?</b> Yes
<b>Current DCR</b> R+	<b>Work Package ID</b> D20-96023
<b>Estimated Improved DCR</b> G+	<b>Budget Category/Account</b> Sustainment-Component Renewal at ESL

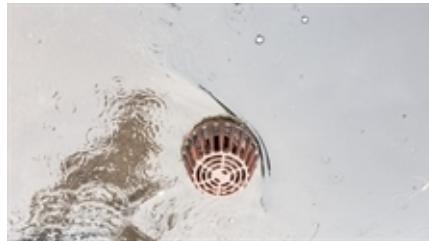
Work Item Number <b>B301002002-102234</b>	Work Item Name <b>Replace Rood Drains/ Roof Covering</b>	Year Observed <b>2019</b>
--	---	------------------------------

**Inventory Classification** B301002002 - Single Ply Roofing

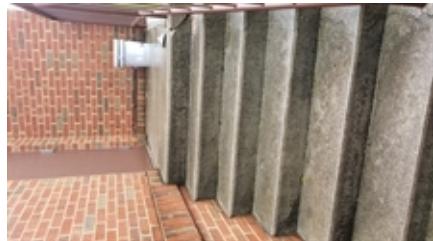
<b>Inventory Classification</b>	C201002003 - Exterior Stairs, Concrete, Steps
<b>Description</b>	With Handrails
<b>Section</b>	-
<b>Distress Type</b>	Cracks
<b>Work Category</b>	Repairs and Replacements
<b>Green Opportunity</b>	
<b>Green Evaluation</b>	
<b>Status</b> Active	<b>Assigned to Work Package?</b> Yes
<b>Current DCR</b> R-	<b>Work Package ID</b> C20-95892
<b>Estimated Improved DCR</b> G	<b>Budget Category/Account</b> Sustainment-Deficiency Repairs/Replacements

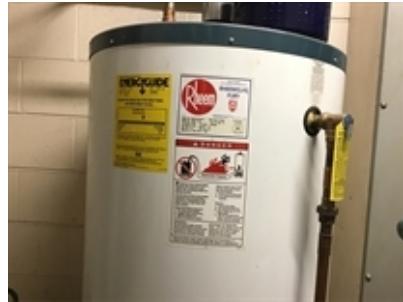
<b>Inventory Classification</b>	D202003018 - Residential Water Heater - Electric or Gas, 100 gal		
<b>Description</b>	Gas Fired Water Heater 75 gal		
<b>Section</b>	1FL		
<b>Distress Type</b>	Deteriorated		
<b>Work Category</b>	Repairs and Replacements		
<b>Green Opportunity</b>	Energy Efficiency		
<b>Green Evaluation</b>	Energy Performance		
<b>Status</b>	Active		
<b>Assigned to Work Package?</b>	Yes		
<b>Current DCR</b>	R+		
<b>Work Package ID</b>	D20-95894		
<b>Estimated Improved DCR</b>	G+	<b>Budget Category/Account</b>	Sustainment-Deficiency Repairs/Replacements

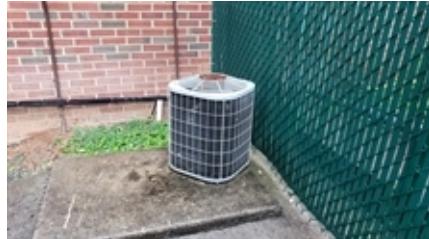
<b>Inventory Classification</b>	D305006017 - A/C Unit, Split Systems w/ Air Cooled Condenser - 2 TN	
<b>Description</b>	A/C Unit 24,000 BTU/hr 208/230 V	
<b>Section</b>	CSF Carrier Condensing Unit	
<b>Distress Type</b>	Deteriorated	
<b>Work Category</b>	Repairs and Replacements	
<b>Green Opportunity</b>	Energy Efficiency	
<b>Green Evaluation</b>	Energy Performance	
<b>Status</b> Active	<b>Assigned to Work Package?</b>	Yes
<b>Current DCR</b> R	<b>Work Package ID</b>	D30-95895
<b>Estimated Improved DCR</b> G+	<b>Budget Category/Account</b>	Sustainment-Component Renewal at ESL

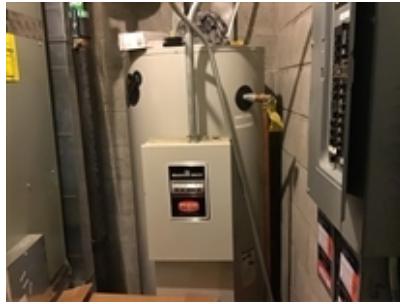
<b>Inventory Classification</b>	D202003019 - Commercial Water Heater - Elec, Gas or Oil Fired - 200 MBH	
<b>Description</b>	Electric Water Heater	
<b>Section</b>	2FL	
<b>Distress Type</b>	Deteriorated	
<b>Work Category</b>	Repairs and Replacements	
<b>Green Opportunity</b>	Energy Efficiency	
<b>Green Evaluation</b>	Energy Performance	
<b>Status</b> Active	<b>Assigned to Work Package?</b>	Yes
<b>Current DCR</b> G	<b>Work Package ID</b>	D20-95903
<b>Estimated Improved DCR</b> G+	<b>Budget Category/Account</b>	Sustainment-Deficiency Repairs/Replacements

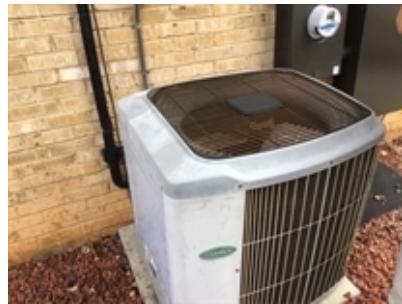
<b>Inventory Classification</b>	D305006018 - A/C Unit, Split Systems w/ Air Cooled Condenser - 3 TN	
<b>Description</b>	2.5 ton Condensing Unit with Split Dx Coil on Furnace	
<b>Section</b>	-	
<b>Distress Type</b>	Deteriorated	
<b>Work Category</b>	Repairs and Replacements	
<b>Green Opportunity</b>	Energy Efficiency	
<b>Green Evaluation</b>	Energy Performance	
<b>Status</b> Active	<b>Assigned to Work Package?</b>	Yes
<b>Current DCR</b> R	<b>Work Package ID</b>	D30-95902
<b>Estimated Improved DCR</b> G+	<b>Budget Category/Account</b>	Sustainment-Deficiency Repairs/Replacements

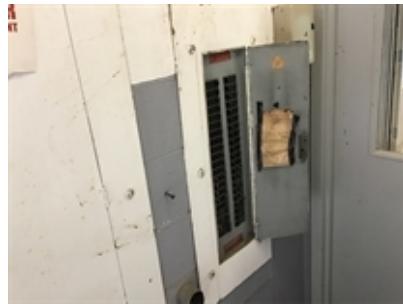
**Inventory Classification** D501005005 - Main Lugs, 120/208/240 V, 225 amp, three phase

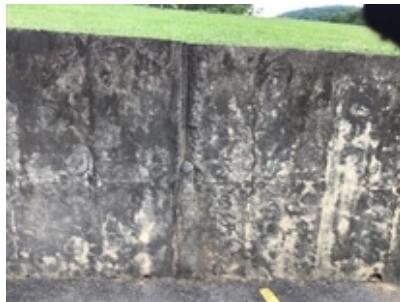
<b>Inventory Classification</b>	G204002001 - Concrete Retaining Wall, 4' High	
<b>Description</b>	Concrete Retaining Wall	
<b>Section</b>	-	
<b>Distress Type</b>	Cracks	
<b>Work Category</b>	-	
<b>Green Opportunity</b>		
<b>Green Evaluation</b>		
<b>Status</b> Active	<b>Assigned to Work Package?</b>	Yes
<b>Current DCR</b> R	<b>Work Package ID</b>	G20-95905
<b>Estimated Improved DCR</b> G-	<b>Budget Category/Account</b>	Sustainment-Deficiency Repairs/Replacements

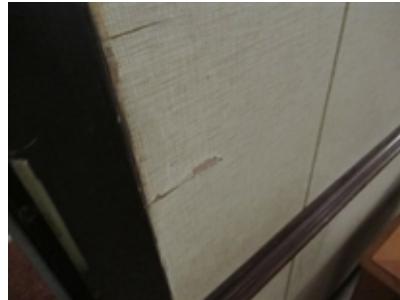
**Inventory Classification** C301006004 - Vinyl Wall Covering**Description** -**Section** -**Distress Type** Deteriorated**Work Category** Repairs and Replacements**Green Opportunity****Green Evaluation****Status** Active**Assigned to Work Package?** Yes**Current DCR** R**Work Package ID** C30-96027**Estimated Improved DCR** G**Budget Category/Account** Sustainment-Deficiency Repairs/Replacements**Priority Rating** 4-Necessary, Not Yet Critical **Recommend Full Component Replacement** Yes**Impact Type** Environmental **Impact Score** 5.5 **High Emphasis** No**Severity** Category I - Catastrophic**Failure Probability** Subcategory C-Failure is likely to occur before next scheduled inspection (3 years).**ACI Priority** 4-Significant **SCI Priority** 2 - Moderate **DCR Priority** 4-Significant **Risk Reduction Index** 6.00

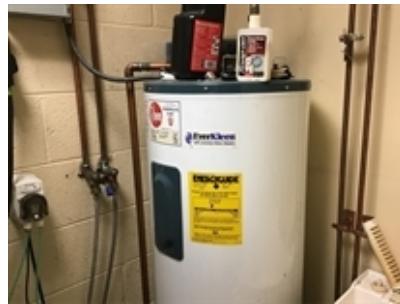
<b>Inventory Classification</b>	D202003017 - Residential Water Heater - Electric or Gas, 50 gal	
<b>Description</b>	Electric Water Heater	
<b>Section</b>	-	
<b>Distress Type</b>	Deteriorated	
<b>Work Category</b>	Repairs and Replacements	
<b>Green Opportunity</b>	Energy Efficiency	
<b>Green Evaluation</b>	Energy Performance	
<b>Status</b> Active	<b>Assigned to Work Package?</b>	Yes
<b>Current DCR</b> R+	<b>Work Package ID</b>	D20-96026
<b>Estimated Improved DCR</b> G+	<b>Budget Category/Account</b>	Sustainment-Component Renewal at ESL

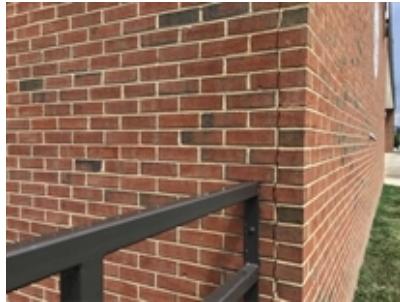
<b>Inventory Classification</b>	B201001010 - Brick Veneer with CMU Backup	
<b>Description</b>	Perimeter walls	
<b>Section</b>	-	
<b>Distress Type</b>	Displaced	
<b>Work Category</b>	-	
<b>Green Opportunity</b>		
<b>Green Evaluation</b>		
<b>Status</b> Active	<b>Assigned to Work Package?</b>	Yes
<b>Current DCR</b> Y-	<b>Work Package ID</b>	B20-96036
<b>Estimated Improved DCR</b> G	<b>Budget Category/Account</b>	Sustainment-Deficiency Repairs/Replacements

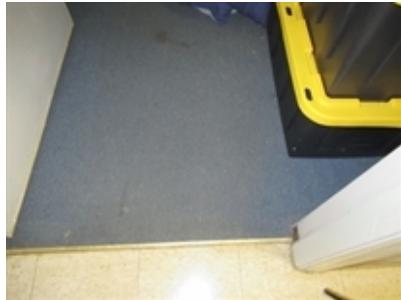
**Inventory Classification** C302005001 - Commercial Grade Carpeting, 35oz Nylon

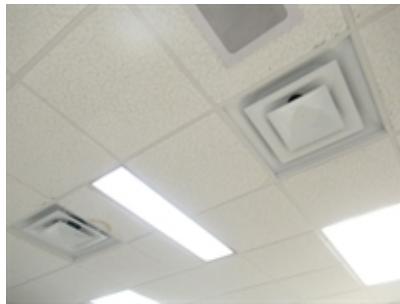
**Inventory Classification** C303004001 - Fiberglass Acoustic Ceiling Tile (2'X2' or 2'X4')

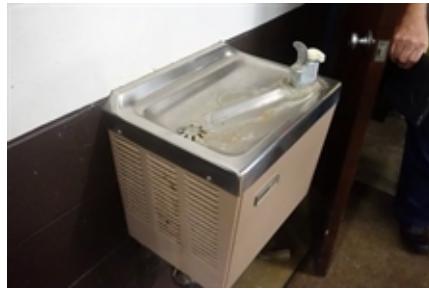
<b>Inventory Classification</b>	D201006002 - Wall Mounted Electric Water Cooler	
<b>Description</b>		
<b>Section</b>	-	
<b>Distress Type</b>	Deteriorated	
<b>Work Category</b>	Repairs and Replacements	
<b>Green Opportunity</b>		
<b>Green Evaluation</b>		
<b>Assigned to Work Package?</b>	Yes	
<b>Work Package ID</b>	D20-96041	
<b>Budget Category/Account</b>	Sustainment-Deficiency Repairs/Replacements
