August 22, 2025

Lead & Asbestos Inspection Report

Roanoke County Fire and Rescue Station #5
7401 Barrens Rd
Hollins, VA 24019

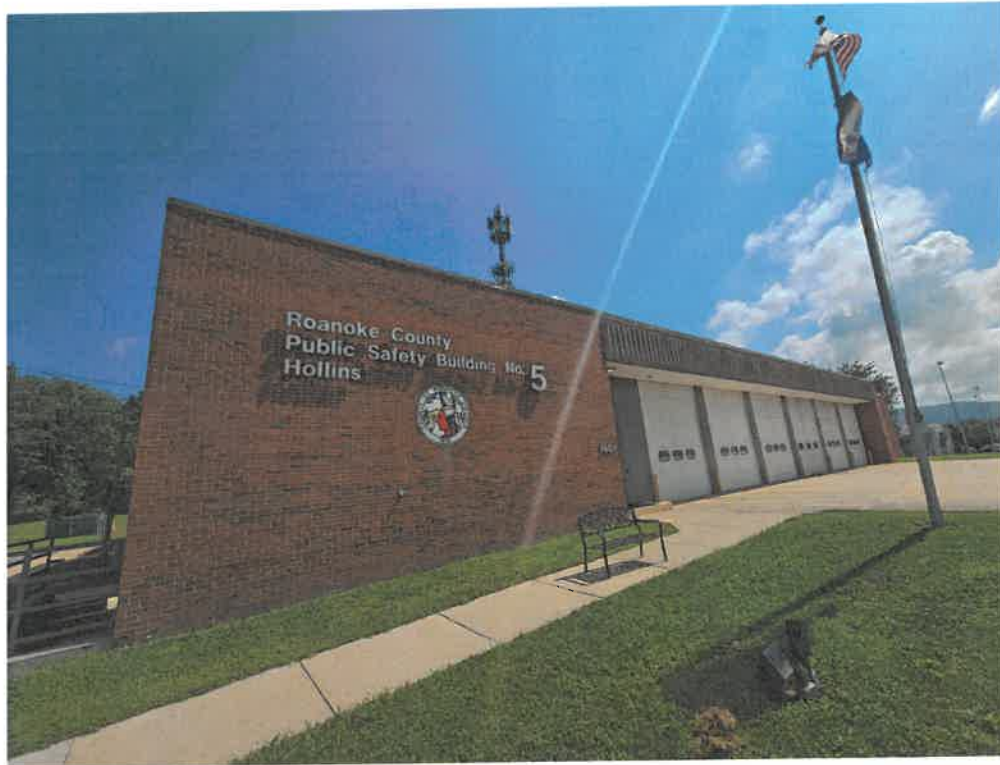
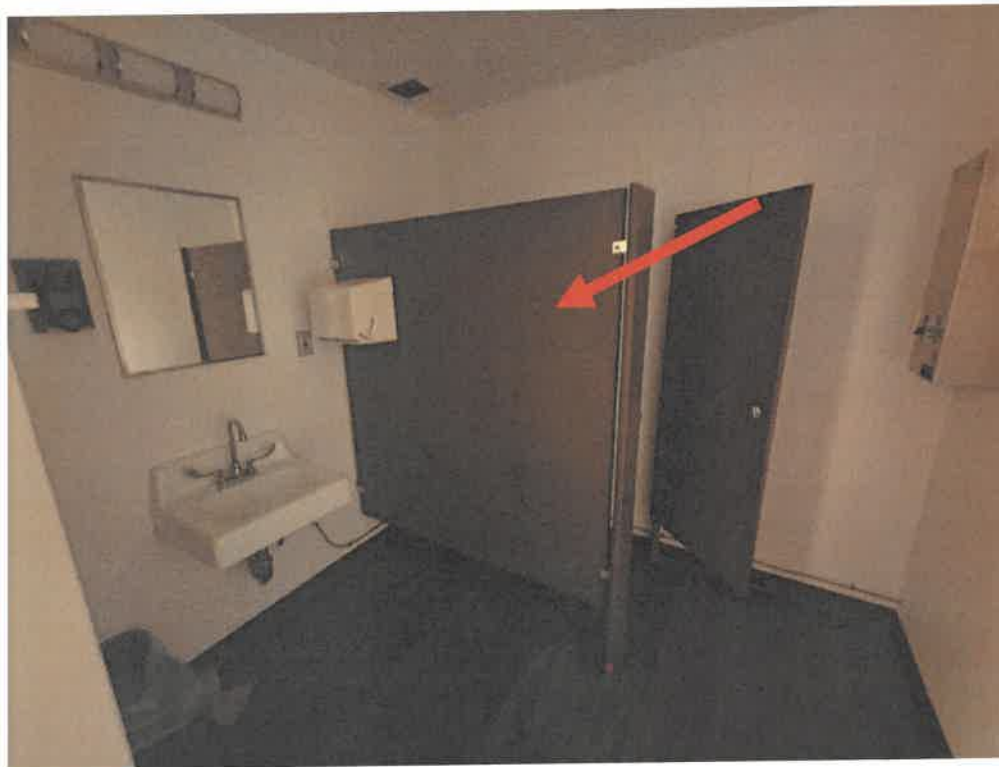
- **The dividing wall in the women's restroom**

The dividing wall in the women's restroom was found to utilize lead-based paint

If lead is present, regardless of quantity, OSHA regulations are applicable. All persons involved in the disturbance of lead based or lead containing painted surfaces should be adequately trained to do so. All contractors should be provided with the results for their use in meeting current OSHA requirements for the protection of their workers and the environment.
