# Common ADA Errors and Omissions in New Construction and Alterations

## Introduction

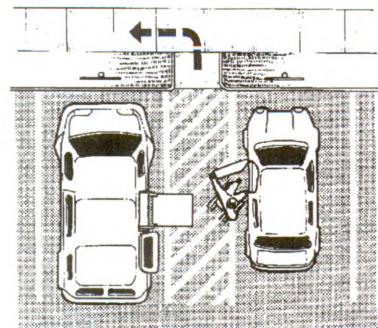
**There is no accessible route from accessible parking to an accessible entrance.**

4.6.3\* Parking Spaces. ...Parking access aisles shall be part of an accessible route to the building or facility entrance and shall comply with 4.3.

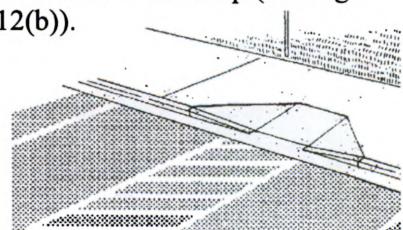
**Curb ramp that is located across a circulation path has steep unprotected side flares.**

4.7.5 Sides of Curb Ramps. If a curb ramp is located where pedestrians must walk across the ramp, or where it is not protected by handrails or guardrails, it shall have flared sides; the maximum slope of the flare shall be 1:10 (see Fig. 12(a)). Curb ramps with returned curbs may be used where pedestrians would not normally walk across the ramp (see Fig. 12(b)).

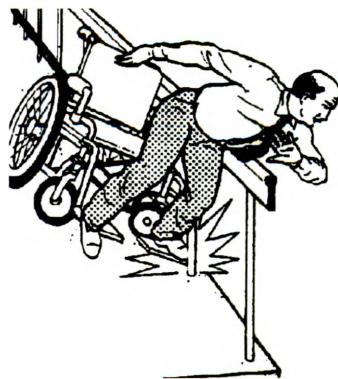
**Parts of an accessible route with slopes that exceed 1:20 lack required features including handrails and edge protection.**

4.8.1\* General. Any part of an accessible route with a slope greater than 1:20 shall be considered a ramp and shall comply with 4.8.

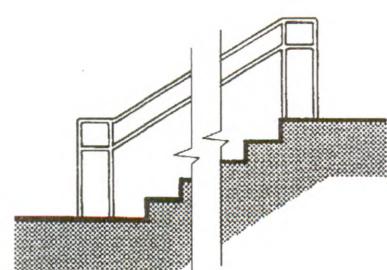
**Handrail extensions are not provided at the top and bottom risers.**

4.9.4(2) If handrails are not continuous, they shall extend at least 12 in (305 mm) beyond the top riser and at least 12 in (305

mm) plus the width of one tread beyond the bottom riser. At the top, the extension shall be parallel with the floor or ground surface. At the bottom, the handrail shall continue to slope for a distance of the width of one tread from the bottom riser; the remainder of the extension shall be horizontal (see Fig. 19(c) and (d)). Handrail extensions shall comply with 4.4.

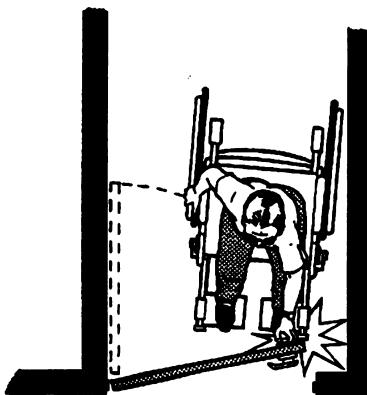
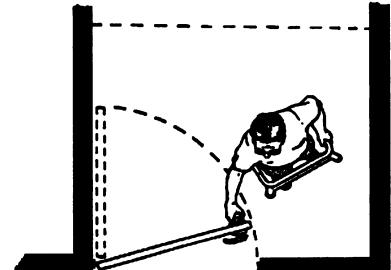
**Adequate maneuvering clearance is not provided at doors, including doors to accessible toilet stalls.**

**4.13.6 Maneuvering Clearances at Doors.** Minimum maneuvering clearances at doors that are not automatic or power-assisted shall be as shown in Fig. 25. The floor or ground area within the required clearances shall be level and clear.

**4.17.5\* Doors.** Toilet stall doors, including door hardware, shall comply with 4.13. If toilet stall approach is from the latch side of the stall door, clearance between the door side of the stall and any obstruction may be reduced to a minimum of 42 in (1065 mm) (Fig. 30).

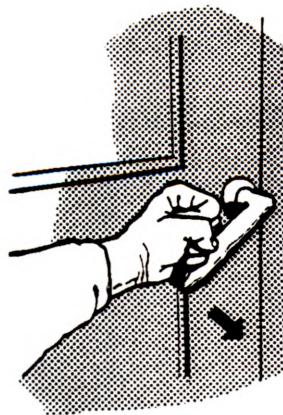
**The shape of the door hardware requires tight grasping, pinching, and twisting of the wrist to use.**

4.13.9\* Door Hardware. Handles, pulls, latches, locks, and other operating devices on accessible doors shall have a shape that is easy to grasp with one hand and does not require tight grasping, tight pinching, or twisting of the

wrist to operate. Lever-operated mechanisms, push-type mechanisms, and U-shaped handles are acceptable designs. When sliding doors are fully open, operating hardware shall be exposed and usable from both sides. Hardware required for accessible door passage shall be mounted no higher than 48 in (1220 mm) above finished floor.

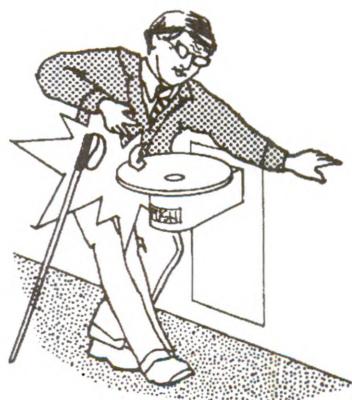
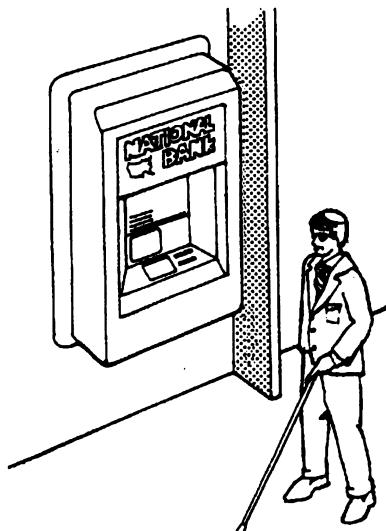
**Objects protrude into circulation paths from the side or from posts.**

**Objects that overhang circulation paths do not provide clear headroom.**

4.4.1\* General. Objects projecting from walls (for example, telephones) with their leading edges between 27 in and 80 in (685mm and 2030 mm) above the finished floor shall protrude no more than 4 in (100 mm) into walks, halls, corridors, passageways, or aisles (see Fig. 8(a)). Objects mounted with their leading edges at or below 27 in (685 mm) above the finished floor may protrude any amount (see Fig. 8(a) and (b)). Free-standing objects mounted on posts or pylons may overhang 12 in (305 mm) maximum from 27 in to 80 in (685 mm to 2030 mm) above the ground or finished floor (see Fig. 8(c) and (d)). Protruding objects shall not reduce the clear width of an accessible route or maneuvering space (see Fig. 8(e)).

4.4.2 Head Room. Walks, halls, corridors, passageways, aisles, or other circulation spaces shall have 80 in (2030 mm) minimum clear head room (see Fig. 8(a)). If vertical clearance of an area adjoining an accessible route is reduced to less than 80 in (nominal dimension), a barrier to warn blind or visually-impaired persons shall be provided (see Fig. 8(c-1)).

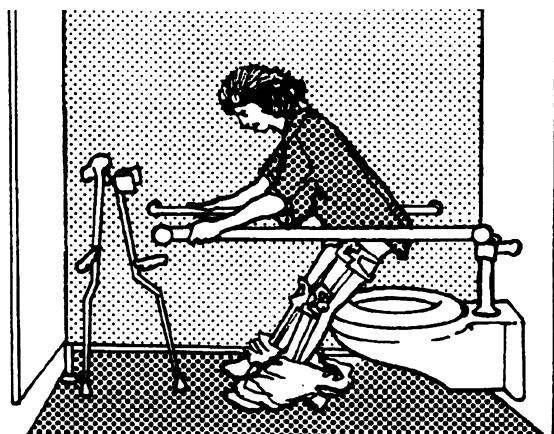
**Toilet rooms with 6 or more toilet stalls lack a 36" wide "ambulatory" toilet stall.**

4.22.4, 4.23.4 Water Closets. If toilet stalls are provided, then at least one shall be a standard toilet stall complying with 4.17; where 6 or more stalls are provided, in addition to the stall complying with 4.17.3, at least one stall 36 in (915 mm) wide with an outward swinging, self-closing door and parallel grab bars complying with Fig. 30(d) and 4.26 shall be provided. Water closets in such stalls shall comply with 4.16. If water closets are not in stalls, then at least one shall comply with 4.16.

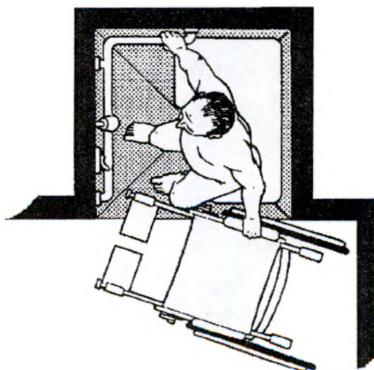
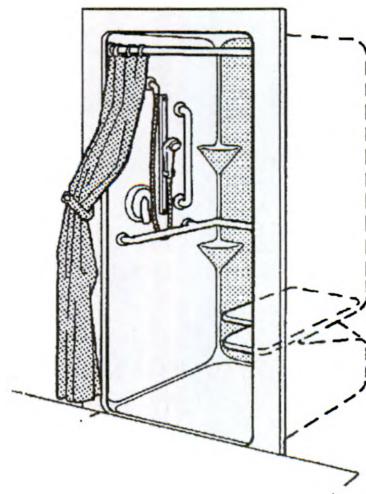
**When a transfer shower is used, it is often larger than the required 36" x 36" size.**

4.21.2 Size and Clearances. Except as specified in 9.1.2, shower stall size and clear floor space shall comply with Fig. 35(a) or (b). The shower stall in Fig. 35(a) shall be 36 in by 36 in (915 mm by 915 mm). Shower stalls required by 9.1.2 shall comply with Fig. 57(a) or (b). The shower stall in Fig. 35(b) will fit into the space required for a bathtub.

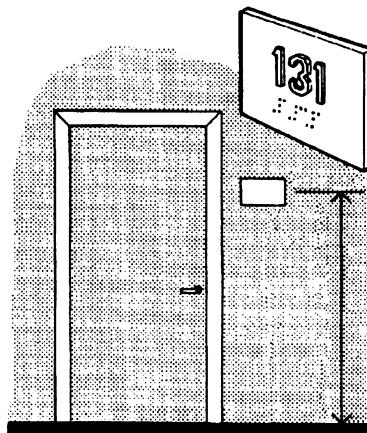
**Where permanent room identification signage is provided, it is mounted in the wrong location.**

4.30.6 Mounting Location and Height. Where permanent identification is provided for rooms and spaces, signs shall be installed on the wall adjacent to the latch side of the door. Where there is no wall space to the latch side of the door, including at double leaf doors, signs shall be placed on the nearest adjacent wall. Mounting height shall be 60 in (1525 mm) above the finish floor to the centerline of the sign. Mounting location for such signage shall be so that a person may approach within 3 in (76 mm) of signage without encountering protruding objects or standing within the swing of a door.

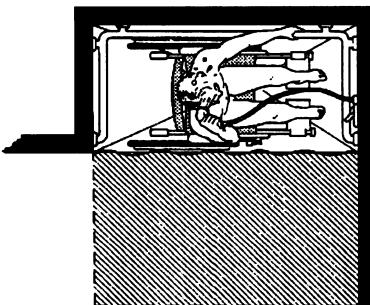
**In hotels, motels, or other lodging facilities of 50 or more sleeping rooms, no rooms with roll-in showers are provided, or the roll-in showers that are provided lack a fold-down seat.**

9.1.2 Accessible Units, Sleeping Rooms, and Suites. Accessible sleeping rooms or suites that comply with the requirements of 9.2 (Requirements for Accessible Units, Sleeping Rooms, and Suites) shall be provided in conformance with the table below. In addition, in hotels, of 50 or more sleeping rooms or suites, additional accessible sleeping rooms or suites that include a roll-in shower shall also be provided in conformance with the table below. Such accommodations shall comply with the requirements of 9.2, 4.21, and Figure 57(a) or (b).

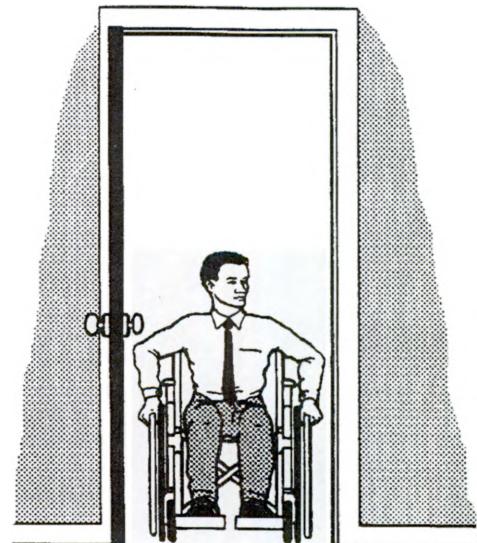
**Doors into and within guest rooms that are not accessible guest rooms do not provide at least 32" clear opening width.**

9.4 Other Sleeping Rooms and Suites. Doors and doorways designed to allow passage into and within all sleeping units or other covered units shall comply with 4.13.5.
